## Rye Brook Pollution Investigations 2014-2017

**Surrey Wildlife Trust**

December 2017

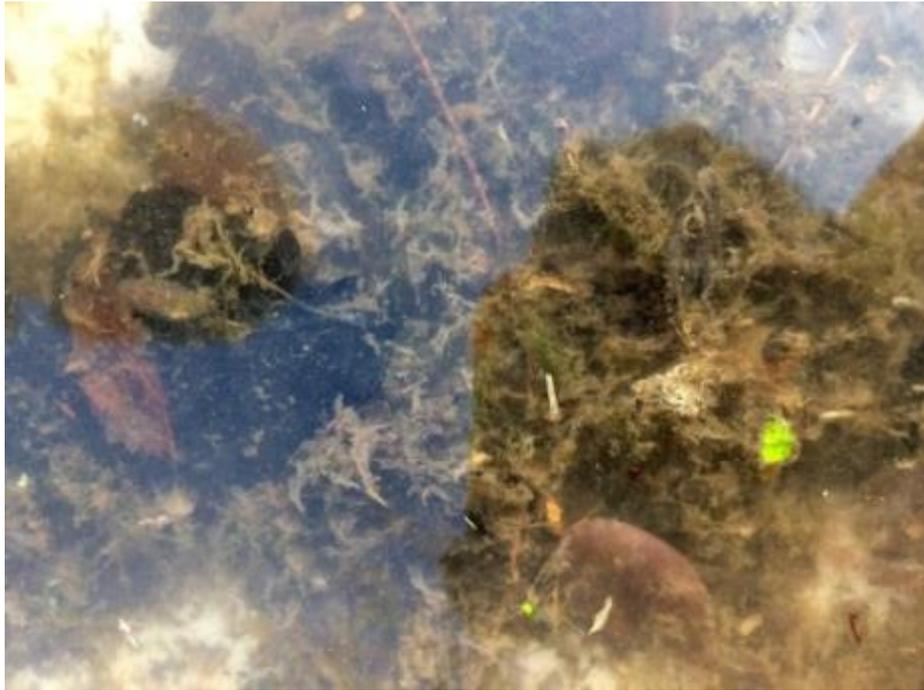
Image 1: Organic material coating the bed

Prior to sampling, it was noticed that organic material was coating the river bed at the point of discharge from the outfall (Image 1). This same point released a black oily fluid when the bed gravels were disturbed during the sample.

The Environment Agency subsequently reported that UKPN and Thames Water have identified the location of the leak from their cable. They have now contained the leak and made a repair. Thames Water has also identified a number of mis-connections in the rainwater sewer network that flows out of the outfall and are working to track down the exact locations and get them rectified. The mis-connections are likely to be from properties that have plumbed in appliances like washing machines to the rain water drain rather than the foul sewer. Locating and rectifying these misconnections can take time but we are now on the way to getting the outfall cleaned up.

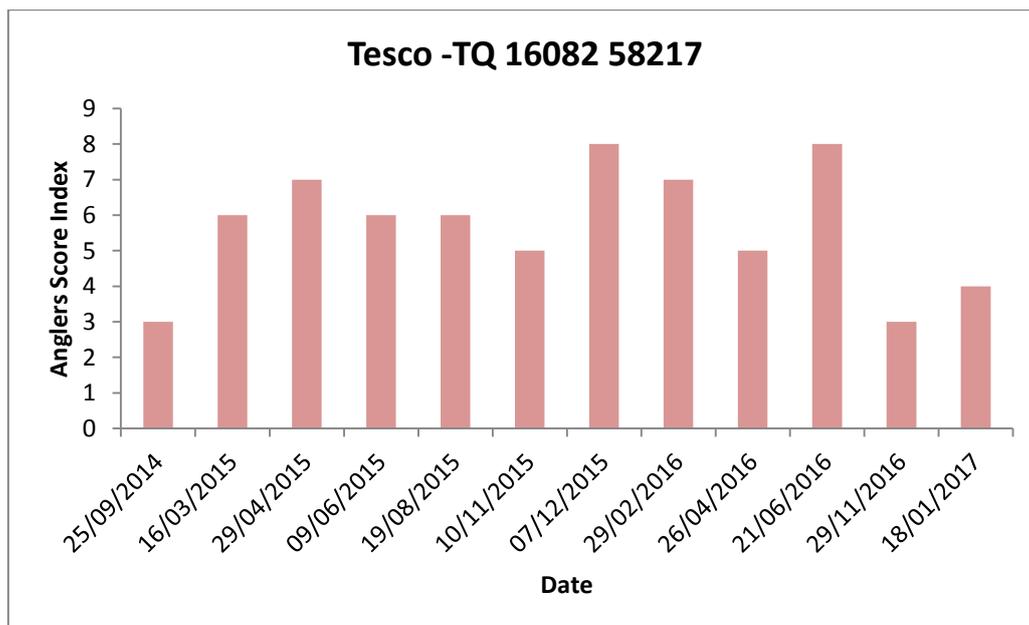
Graph 5: Rye at Tesco monitoring results 2014 - 2017

Regular monitoring has also been carried out on the Rye as it runs past Tesco supermarket. This monitoring site is 2.25km downstream from the outfall. The built up area around this stretch leaves it vulnerable to urban diffuse pollution which is reflected in the scores. For example, the scores dropped from a high of 8 in June 2016 to a low of 3 in November 2016, indicating an issue at some point between these dates. The average score however is higher than the other 2 sites.

**Average score = 6.25**
